Final Report
Prepared for US DoT
Contract Number: DTPH56-13-T-000006

**Development, Field Testing and Commercialization
of a Crack and Mechanical Damage Sensor
for Unpiggable Natural Gas Transmission Pipelines**

NYSEARCH / Northeast Gas Association

May 2016

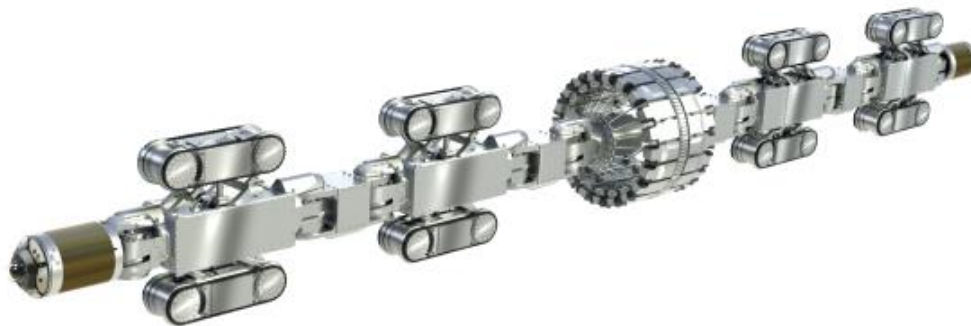
Figure 1: Explorer 20-26

In 2001, NYSEARCH initiated and led an effort to develop ILI technologies for unpiggable pipelines. Following a feasibility study that proved the potential of robotics and sensory technologies to meet the system requirements and the many challenges of unpiggable lines, a development effort was started in 2004 with cofunding from NYSEARCH, PHMSA/DoT, NETL/DoE and OTD to develop the necessary tools. The Explorer family of robotics systems resulted from this effort. These are robotic platforms able to travel on their own battery power through unpiggable pipelines. They communicate with the operator through wireless communication and carry sensors for the non-destructive evaluation of pipelines. Six robotic platforms, i.e. the Explorer 6 (i.e. for pipe sizes of 6” carrying a Remote Field Eddy Current sensor and currently being redesigned to carry a Magnetic Flux Leakage sensor), Explorer 8 (i.e. for pipe sizes of 8” carrying a Magnetic Flux Leakage sensor), Explorer 10/14 (i.e. for pipe sizes of 10”-14” carrying a Magnetic Flux Leakage sensor), Explorer 16/18 (i.e. for pipe sizes of 16”-18” carrying a Magnetic Flux Leakage sensor), Explorer 20/26 (i.e. for pipe sizes of 20”-26” carrying a Magnetic Flux Leakage sensor; and also known during the R&D program as TIGRE; see Figure 1) and Explorer 30/36 (i.e. for pipe sizes of 30”-36” carrying a Magnetic Flux Leakage sensor) are commercially available providing the industry with unique capabilities for inspection of unpiggable pipelines.

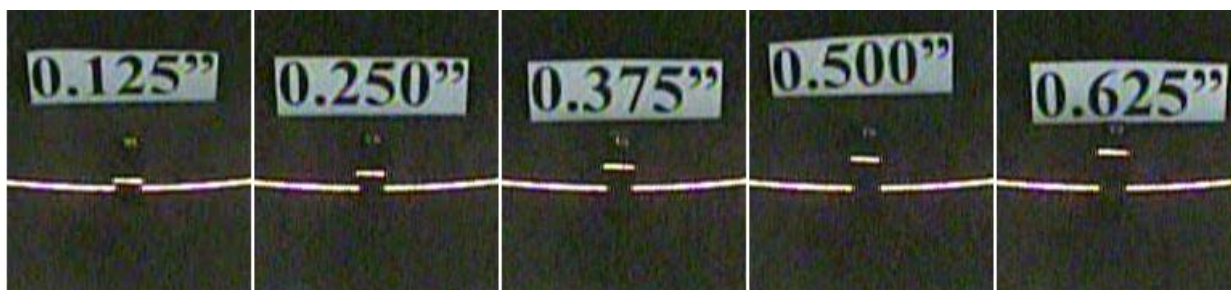
Figure 7: Sample view of deflection of the laser ring for different heights

Figure 7 were taken in a 20-in pipe with 0.250in wall thickness. A small block of varying height was placed across the laser ring and the picture was taken. For blocks even as small as 0.125in, the variation can be seen. For a 20in pipe this corresponds to 0.6% of the overall diameter, which is within the target value of 2%.

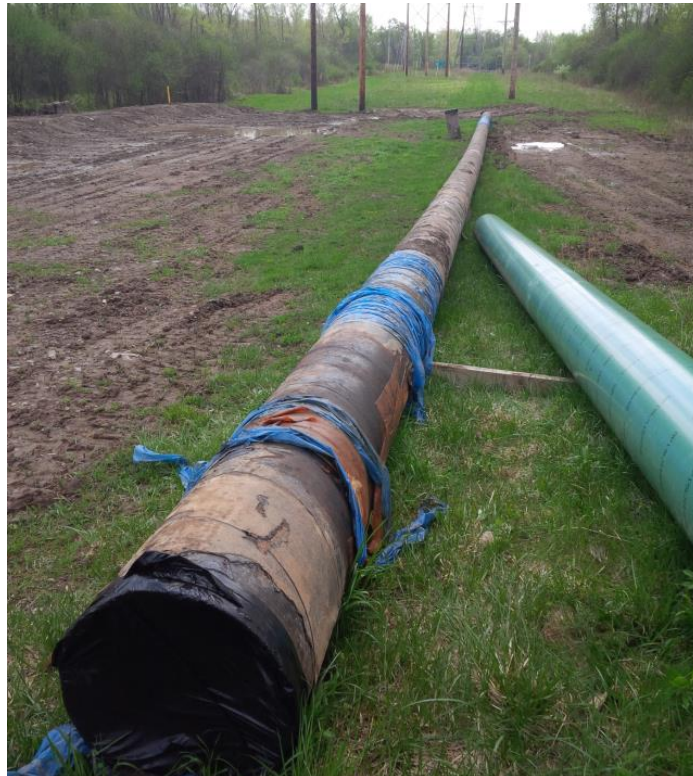
Figure 17: 22.5" OD, 0.25" WT pipeline segment

The pipeline provided for testing by NYSEARCH (see Figure 17) was owned by a NYS utility and was carried out on location. It had been removed from the ground intact. It had been removed due to suspected integrity issues in two girth welds located at the end of the segment. The segment was over 150 ft long with girth welds every 20 ft. The pipe was installed in 1951 and was 22.5 in in diameter with a wall thickness of 0.25 in. The pipe was cleaned prior to testing.

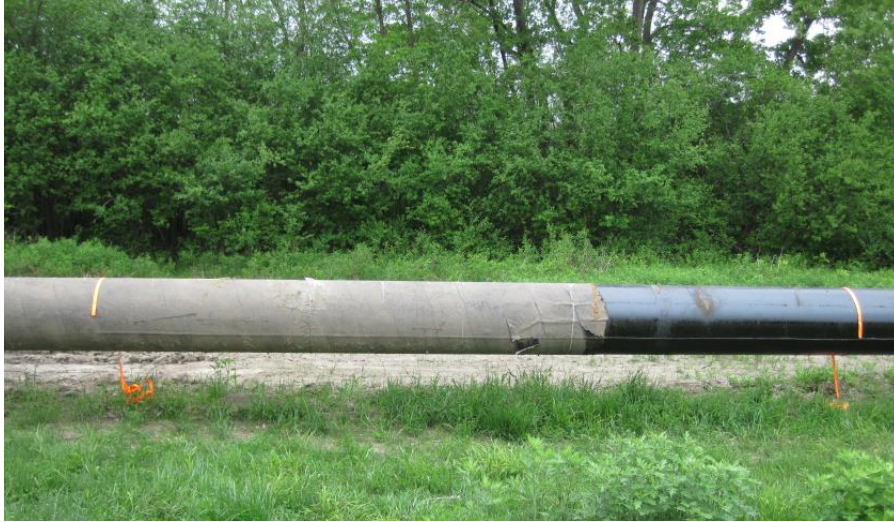
Figure 18: Coal tar coating partially removed from pipeline segment.

The original coal tar coating on the outside of the pipe had been removed in some areas in order to evaluate the condition of the pipe due to integrity concerns at each end of the pipe (

Figure 18). Furthermore in preparation for the test, NYSEARCH removed the coating on some of the pipe including a 60 ft segment in the middle of the pipe. This was done in order to test the sensor for both cases of a coated and non-coated pipeline.

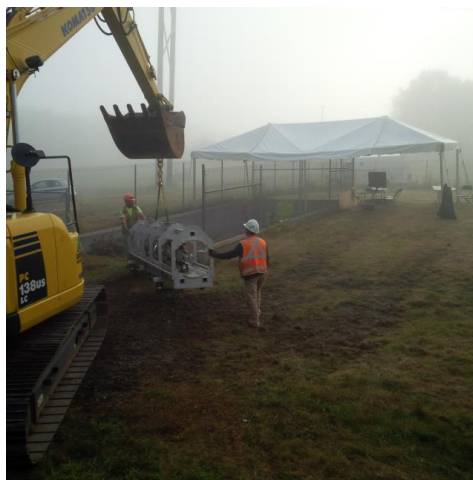
Figure 22: Crack sensor deployed into NYSEARCH underground test loop

Following this first demonstration and in preparation for the second demonstration it was agreed to carry out an operational test of the TMFL/EMAT sensor at the underground test loop owned and operated by NYSEARCH Binghamton, NY on July 30th, 2014, shown in Figure 22. The test loop in Binghamton NY, is an underground section of pipe

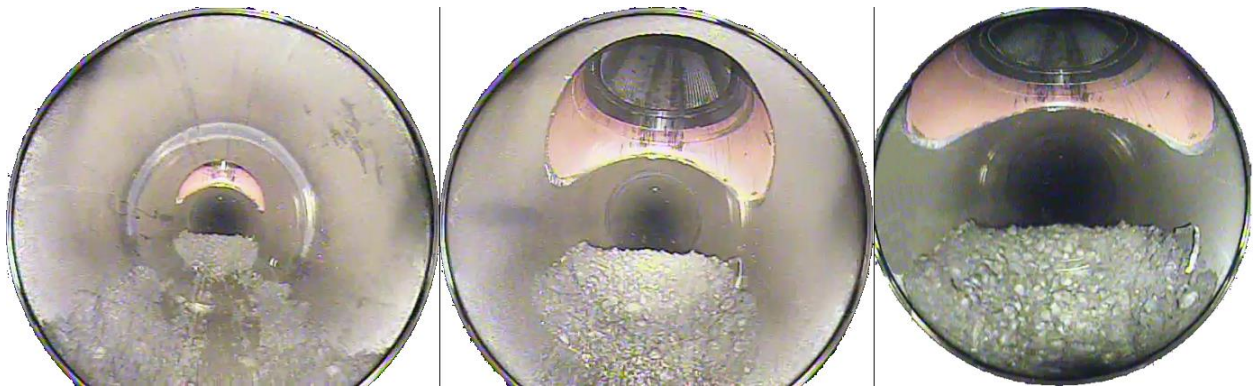
Figure 31: Views of debris from different positions near the hot tap

Following the cancellation of this demonstration, NYSEARCH staff initiated an immediate search to identify an alternate location. A new location was secured in the west coast and the second demonstration was carried out under live conditions on November 14, 2014, in a 20 in pipeline with a wall thickness of 0.312in. The sensor was installed onto the robot and function tests performed (Figure 29). The system was deployed into the pipeline (Figure 30) where large amounts of debris were encountered. The debris can be seen in Figure 31 with accumulated section near the hot tap entry point.

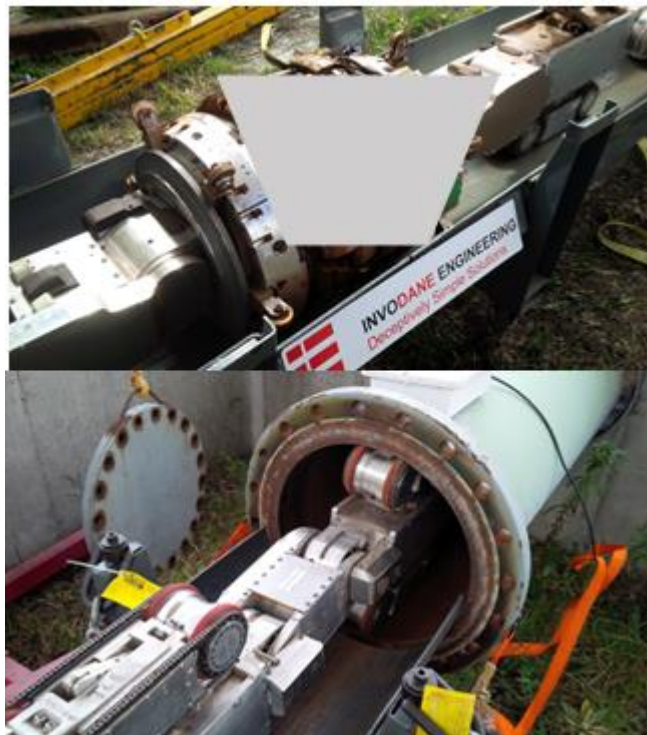
Figure 35: Robot with crack sensor prior to launching

The third field deployment of the crack sensor took place in the NYSEARCH Test Bed in Johnson City, NY, on October 5-6, 2015. The sensor was deployed in the 20" segment of the piping network (with a wall thickness of 0.250") and inspected part of that segment, from the inlet point to the point where there is a plug valve. During the first day the crack sensor and robotic platform systems were checked for proper operation and the network was prepared to receive the system. During the second day the robot was launched into the pipe from an open end (Figure 35) and proceeded to inspect the pipe. The inspection was successful in that the robot was able to negotiate all features without any problem and the TML and EMAT sensors collected a full set of data.

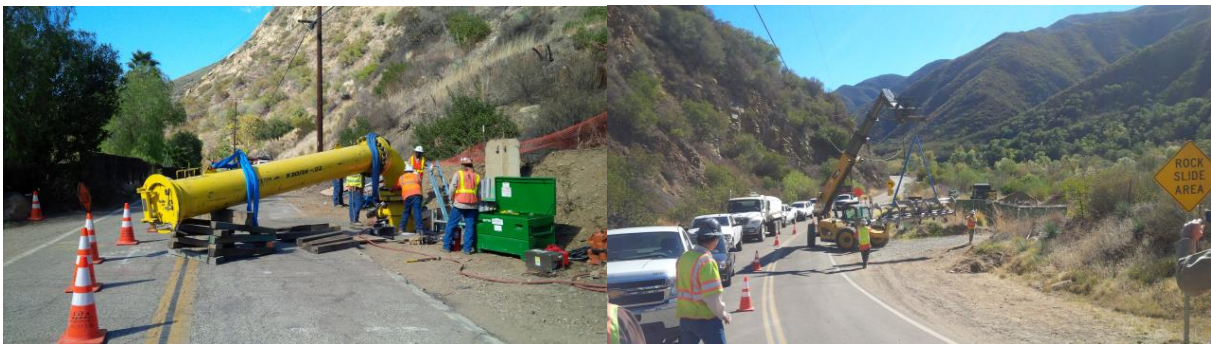
Figure 39: Installation of launcher at fourth demonstration site

Operational procedures call for the launcher to be installed parallel to the pipeline. This ensures the efficient and reliable launching of the robot into the pipeline. However, in this case installing the launcher this way would completely block traffic on the road. It was decided to install the launcher at an angle of 15-deg to the pipeline, an angle that would keep one lane open and would minimize the impact on the launching routine (Figure 39). As mentioned above, repairs were made on the pipeline prior to the deployment, which can be seen in Figure 40.
